CARPET STORE FIRE

Branford, CT

November 28, 1996

**Carpet Store Fire
One Fire Fighter Fatality
Branford, CT
November 28, 1996**

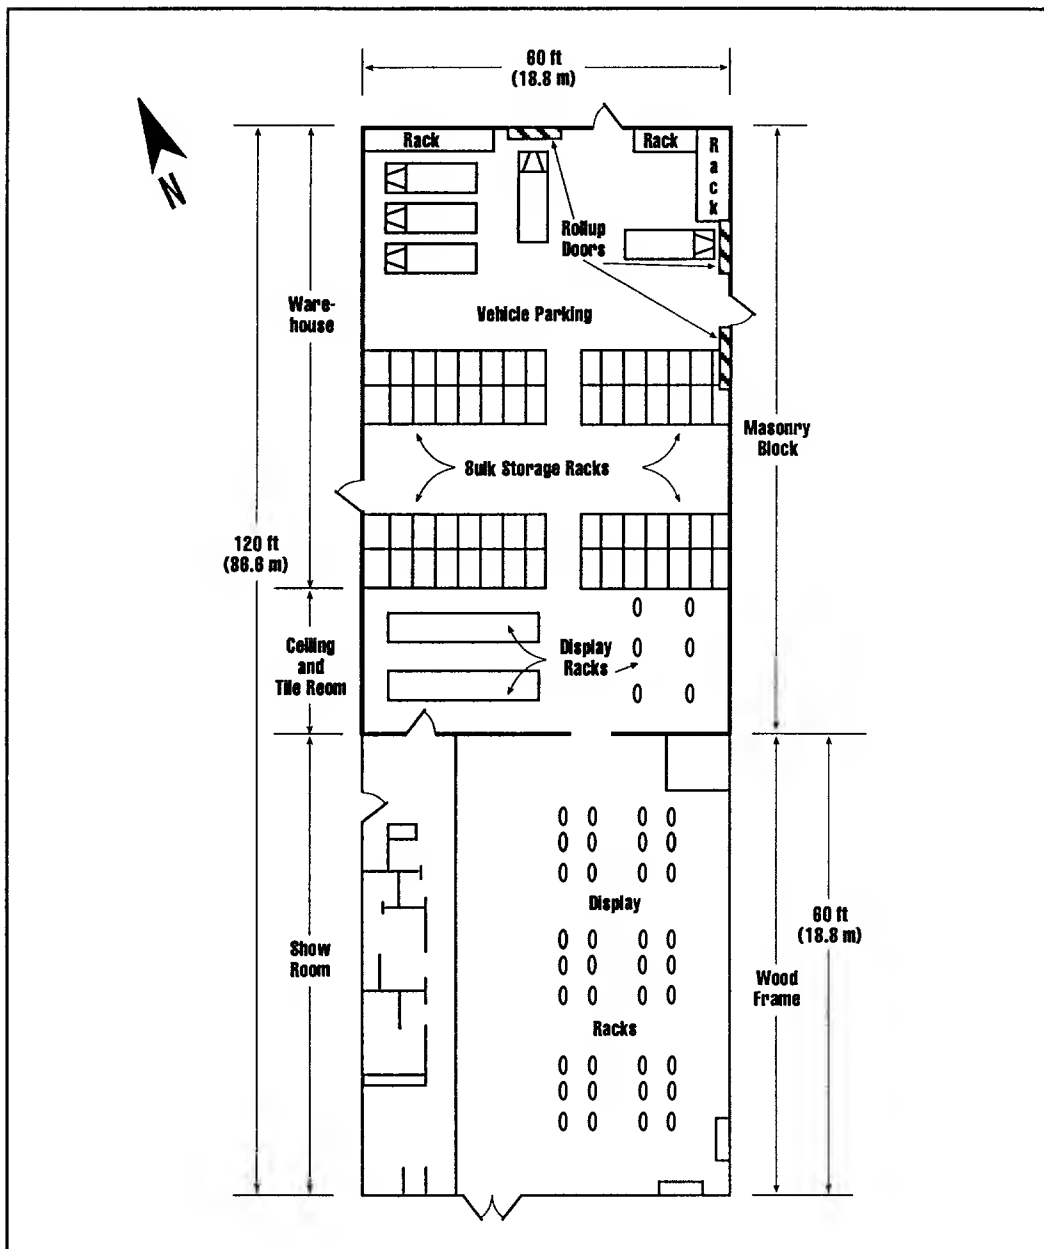
Figure 1: Plan view showing carpet store

The carpet store was in a 7,200-sq ft (669-sq m) building that contained showroom areas, offices, and a warehouse area. (See Figure 1.) Each area had at least one exit providing direct access to the exterior of the building. Both the office area and the warehouse supported the facility's primary function, namely, the retail sale of carpet and tile products. Since the facility was primarily a store, the Branford carpet store will be considered a Class B Mercantile Occupancy according to the 1994 edition of *NFPA 101®*, *Life Safety Code®*.^{1,2}

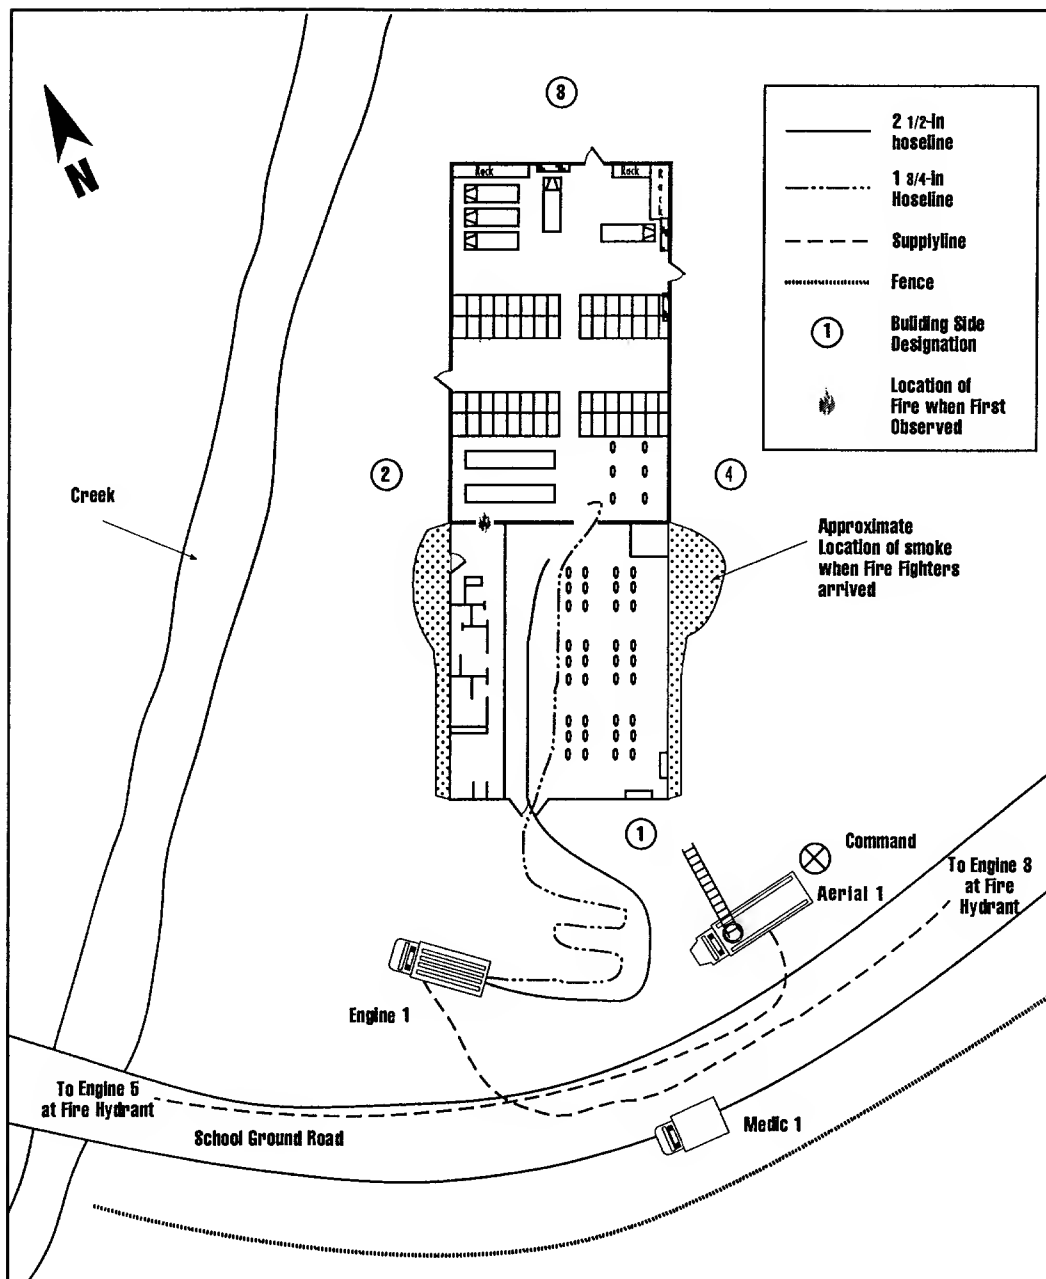
Figure 2: Fireground operation

The incident commander left Engine 1 and proceeded up to the fire building to begin his initial size-up while the supply line was being removed from the engine. As this officer approached Side 1 and Side 4 corner of the building, he found light brownish-gray smoke showing near the roof eaves and coming from soffit vents.⁵ (See Figure 2.) The smoke appeared to be coming from the wood-frame section of the building, and the smoke was heaviest in the back of this section near where the construction changed to masonry block.
